Consolidated Update

Dated 23rd April, 2024 – St George’s Day

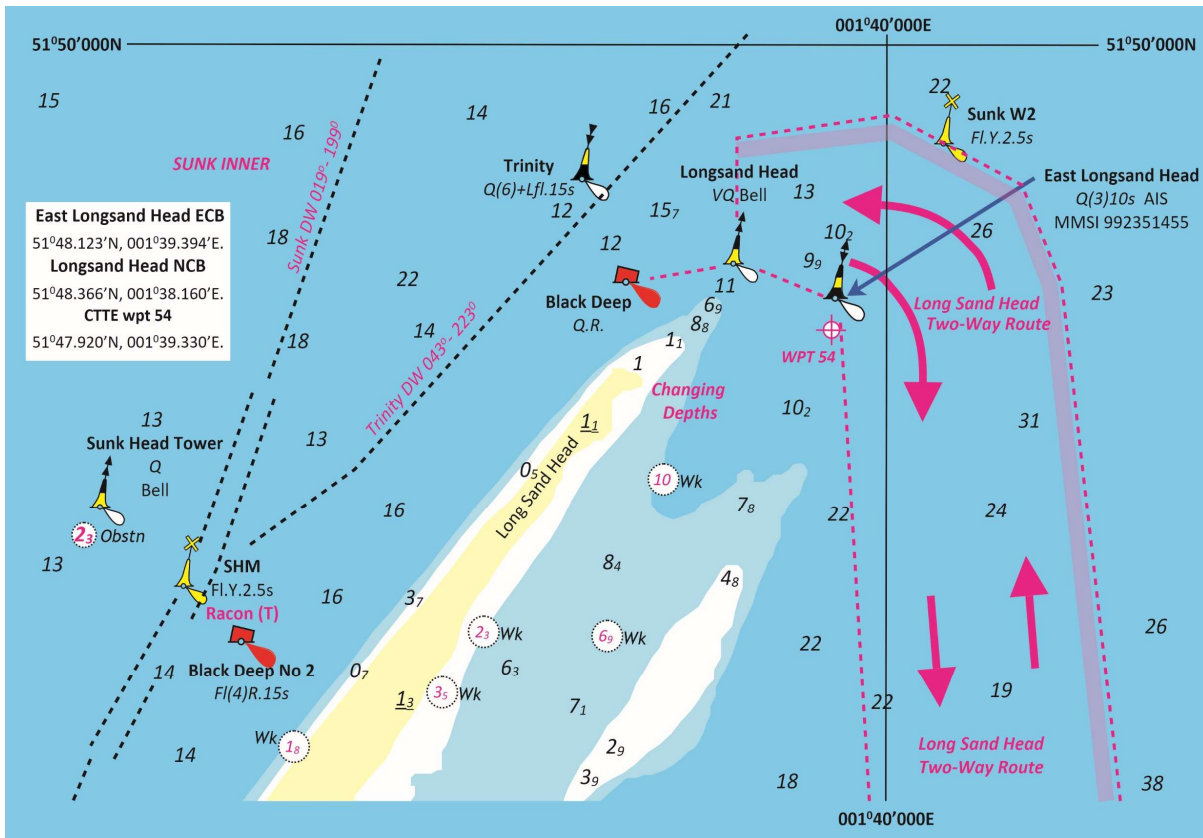
Trinity House have just issued a Notice to Mariners providing us advance notice of changes at the Long Sand Head. The changes are planned to be actioned “on or around 17th May, 2024”. In the past 12 months, the Long Sand Head has continued gently, but persistently, to creep more to the northeast. For us there is no crisis but heed the warning not to ‘cut the corner’. For shipping using the Two-Way Route in and out of the Black Deep two changes have been necessary.

The creation of a new east cardinal buoy. This will be positioned very close to current position of the Longsand Head north cardinal buoy. The new buoy will be designated ‘East Longsand Head’. Characteristics are shown in the chartlet. Note it will have AIS.

The Longsand Head north cardinal buoy will be moved west and a little north. As you will see in the chartlet the effect is to make the corner clear for shipping. Characteristics for this buoy will remain as at present.

The only CTTE routes involved are Routes 26 and 31 (Page 119): the ‘Outside’ routes between Ramsgate and Harwich Harbour or the Deben. At the Long Sand Head, CTTE has Waypoint 54. I consider that, at present, there is no need for the waypoint to be moved. As you will see the waypoint is located clear of the Two-Way Route TSS yet has ample water for leisure craft.

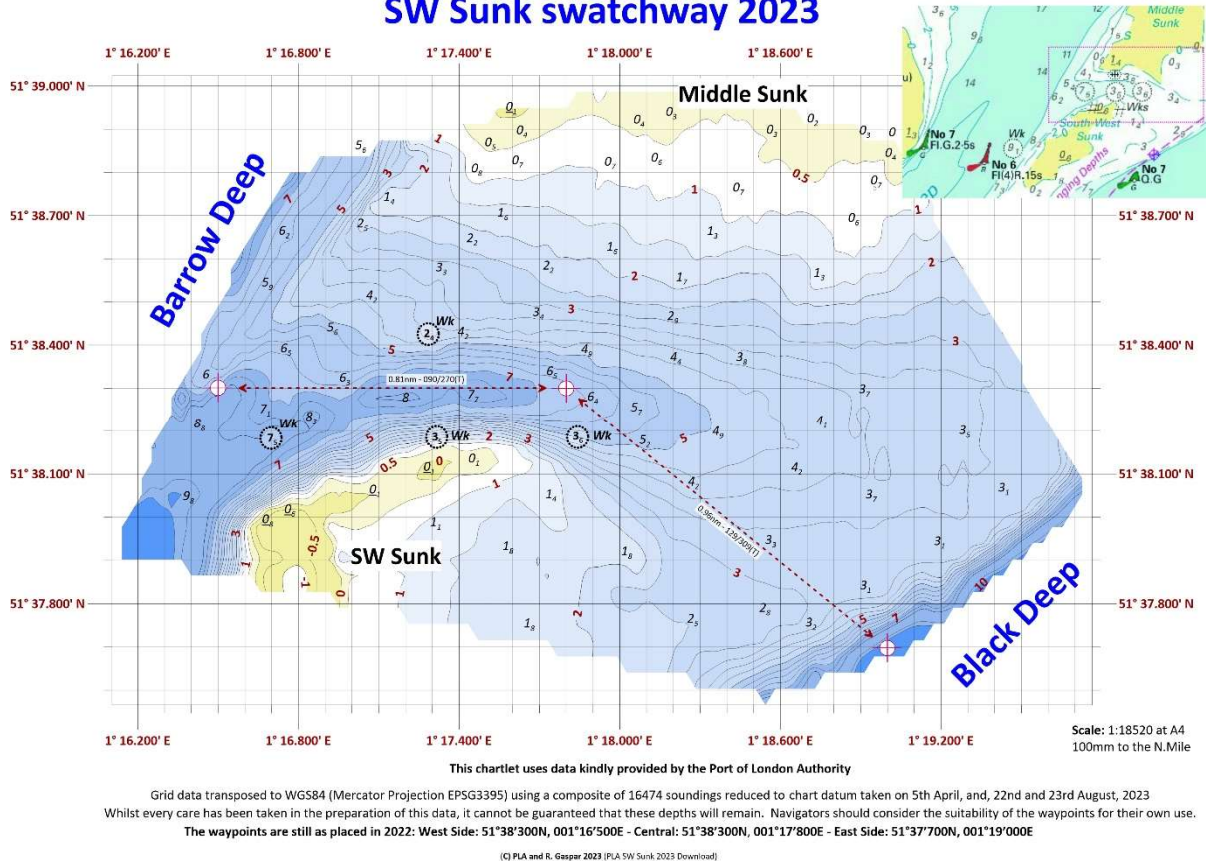
SW Sunk swatchway 2023

Courtesy of some excellent work by the Port of London Authority, we can update on the SW Sunk. The short message is that the 'object' found this year in the swatch is a wreck and there is 2.4m CD over it, the SW knoll has been stable (i.e. it has not moved much if at all) and the SW edge of the Middle Sunk sand has continued to retreat (i.e. usable water in the swatch is wider).

The conclusion is that the swatch remains feasible and whilst we will, of course, go back down there again next Spring, we would be very surprised if there was a problem. The three waypoints remain fine.

It seems clear that the discovery of the 'new' wreck was achieved because the sand in that area has been scoured away. Where the sand has gone is, of course, unknown. Perhaps it has continued to hamper the Middle Sunk crossing on the other side. We will consider going there next year.

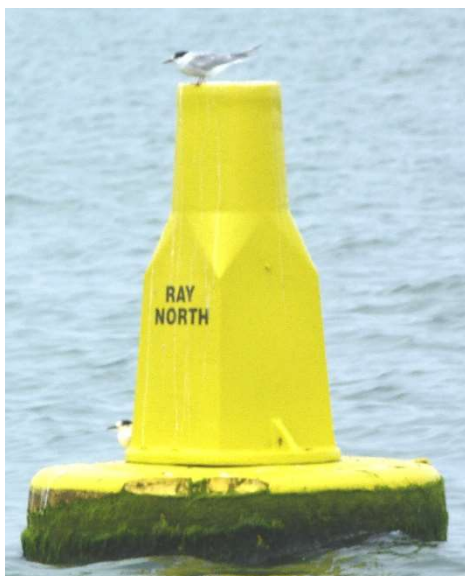
The Ray Sand North: Special Yellow Unlighted Pillar Buoy at **51°40'.81N., 001°00'.57E.**

I suspect Trinity House required the Crouch HA to change the buoyage to a special mark rather than a safe water buoy. We did find in some daylight, spotting the mark was not quite as easy.

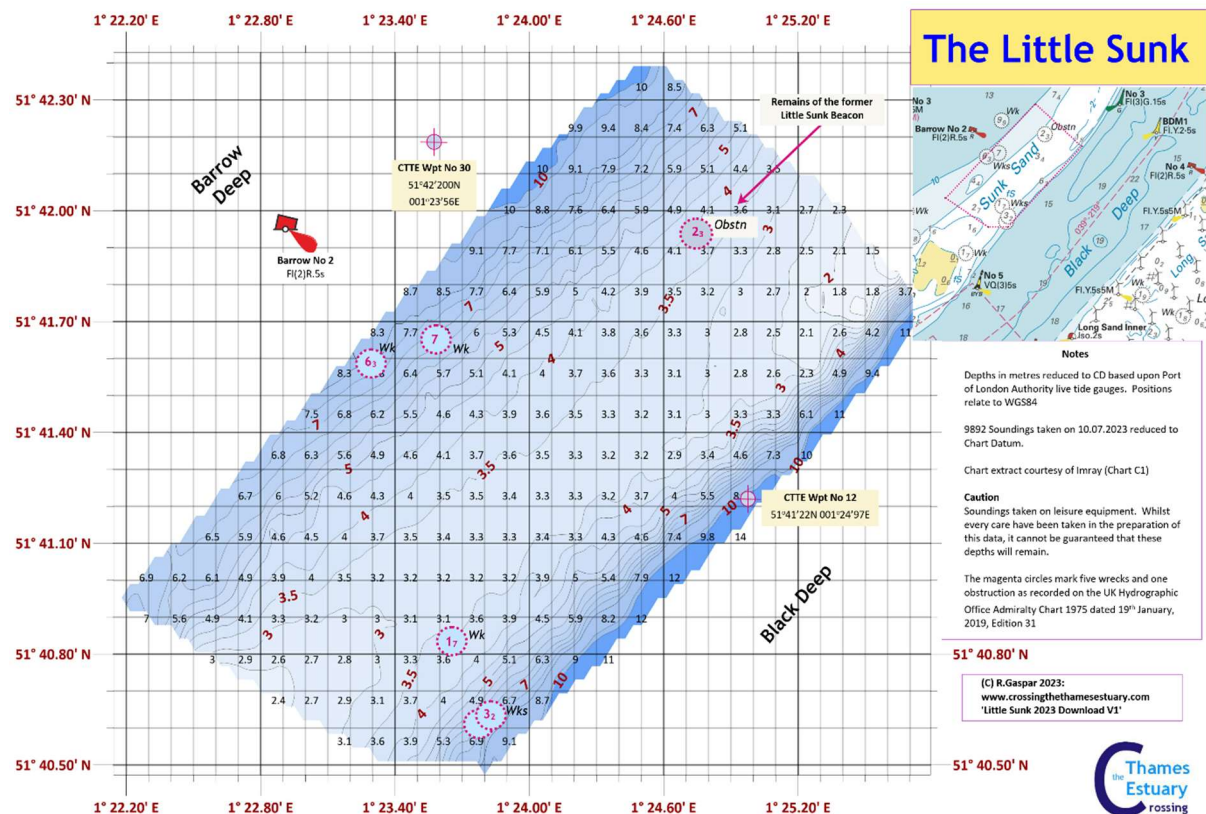
2. The Little Sunk crossing point (Page 24):

On 10th July, 2023 we completed a successful survey at the Little Sunk. We thought conditions might be unsuitable but to our surprise locally we had 4 to 7kts of wind and was perfect. The results are good, little change; in the central area there is 3.2m CD minimum.

Waypoint 12 is positioned to use either to or from the Essex or Suffolk Rivers but when you studied the chartlet you can there is plenty of 'room' to adjust where exactly you cross. Download the new chartlet at: <https://www.crossingthethamesestuary.com/page29.html> (scroll down to item 5)

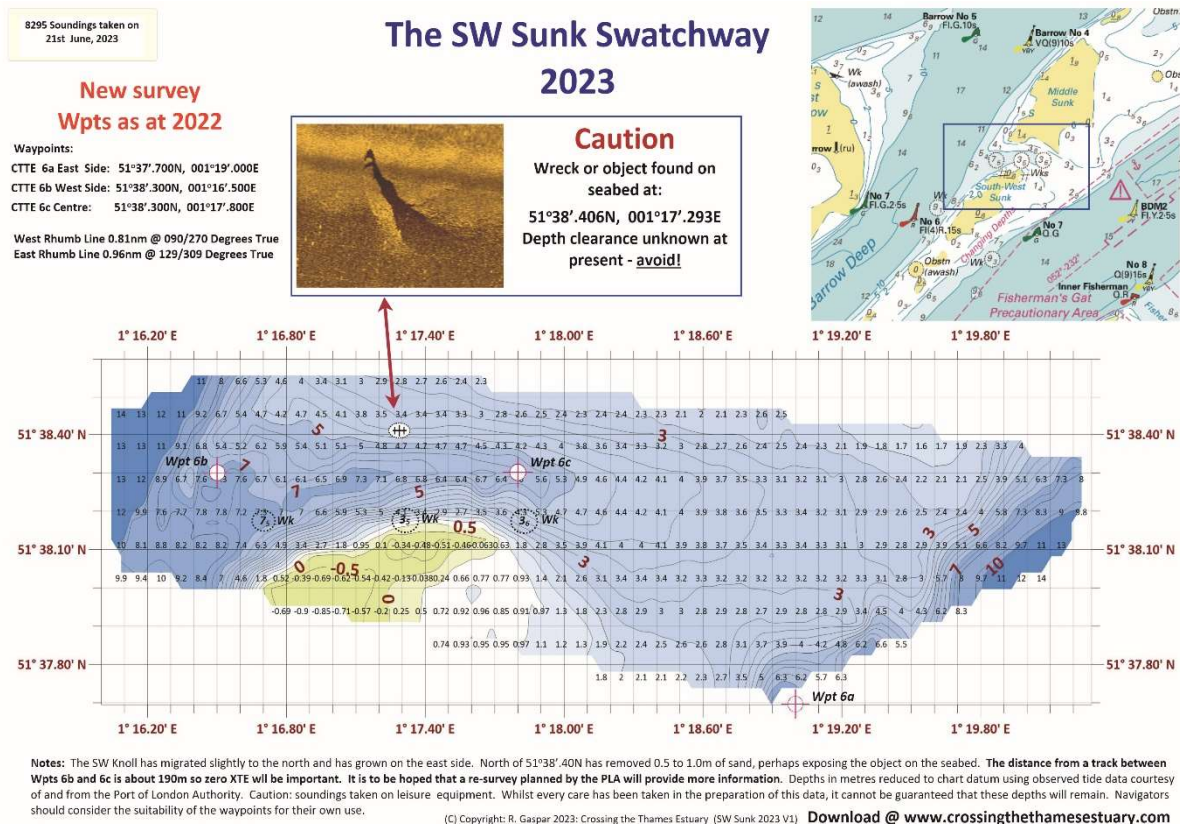
All who have received the mailshot in June, will be aware of the developments at the SW Sunk. The swatchway is fine and feasible but the new obstruction needs to be avoided. To date there is no additional information about the object.

The survey in June, 2023 found the depths remained good but the SW Sunk knoll had migrated about 50m northeast and the drying area had extended to the east. The Middle Sunk side had also migrated, indeed on the southwest side of the Middle Sunk knoll 0.5m to 1.0m of sand had gone. During the survey the side scan found the object illustrated on the new chartlet. The nature of the object is unknown at present and I regret I am unable to estimate the clearance over the object. It might be that the object has simply been exposed by the removal of a metre of sand or it could be debris that has arrived.

But there is good news that the location of the object is known as shown on the chartlet. Quite a few have used the swatchway, taking care to remain on track between the recommended waypoints. In the right conditions and with reliable GPS kit, the swatchway is fine.

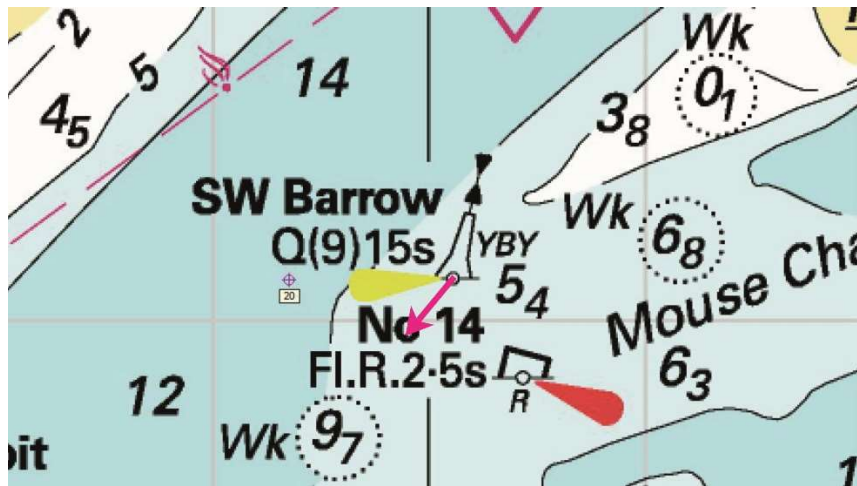
2. The SW Barrow west cardinal buoy: Trinity House notified a move for the SW Barrow buoy on 6th September, 2022 to 51° 31'950N., 000° 59'900E in consequence of a recent survey; the West Barrow sands appears to continue to move to the south west and the buoy had last been moved in 2019.

Waypoint 20 is adjacent but does not need to be moved; only the description of the waypoint on page 11 needs amendment to "SW Barrow bears 114°, 0.37nm". The image shows the location.

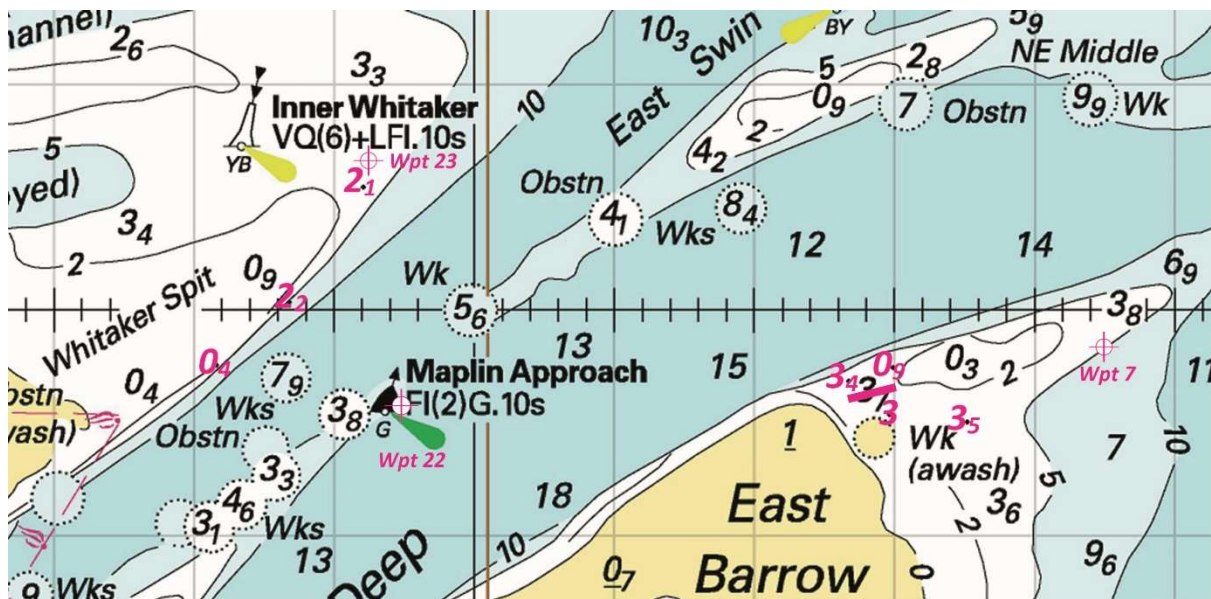
3. Whitaker Spit and the East Barrow Sand: As a result of a Port of London Authority survey earlier this year, the UKHO issued a Notice to Mariners two weeks ago notifying reduced depths at the Whitaker Spit (3) and the East Barrow Sands (4). The image shows the results and waypoints 7, 22 and 23:

If passing either direction between waypoints 22 and 23 bear in mind the height of tide over the edge of the Whitaker Spit. If heading to and from the SW Sunk swathway bear in mind that waypoint 7 remains fine. Some have cut the corner of the East Barrow Sand between the 'north east finger' and the main sands. It remains feasible with care. NOTE that Navionics have not yet updated their chart (as at 14.09.22). I am unable to say where C-Map or others have updated these changes.

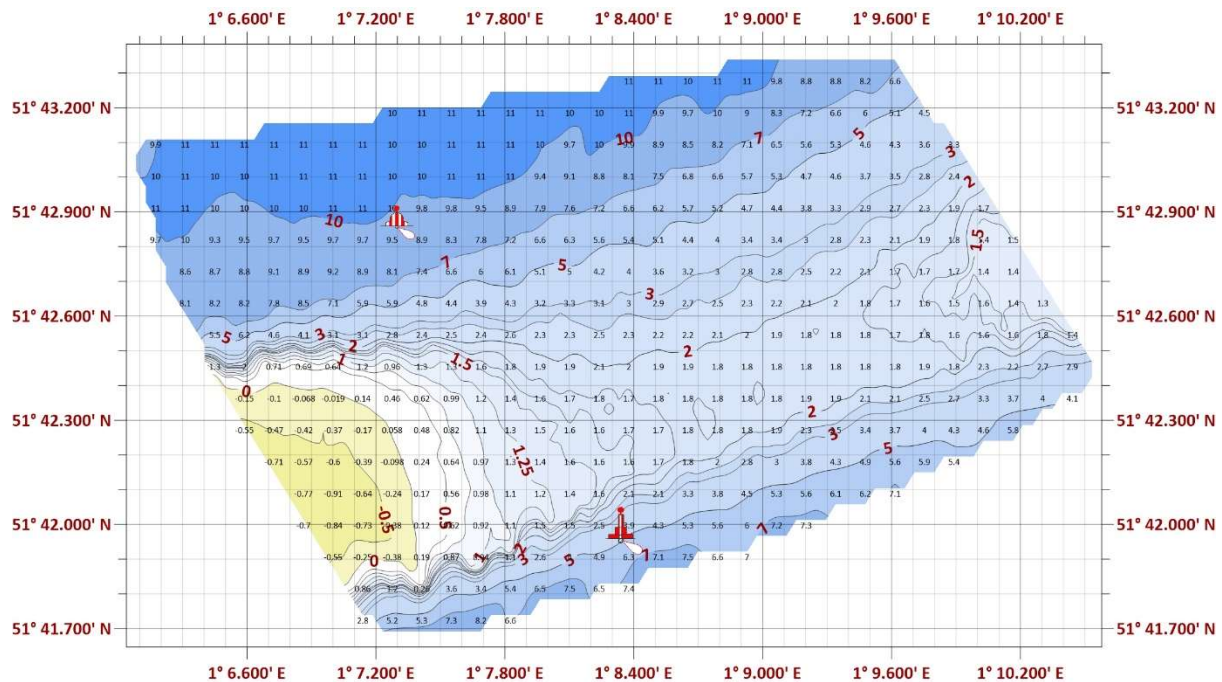
1. The Spitway: On the 30th May, we conducted a survey of the Spitway. Lovely flat conditions during the process which was very convenient and makes accuracy simple. The conclusion is that the swathway has changed very little. It remains the best water to the east of the safe water buoys at 1.8m at chart datum. There is a new download comprising the chartlet and some notes and profiles at:

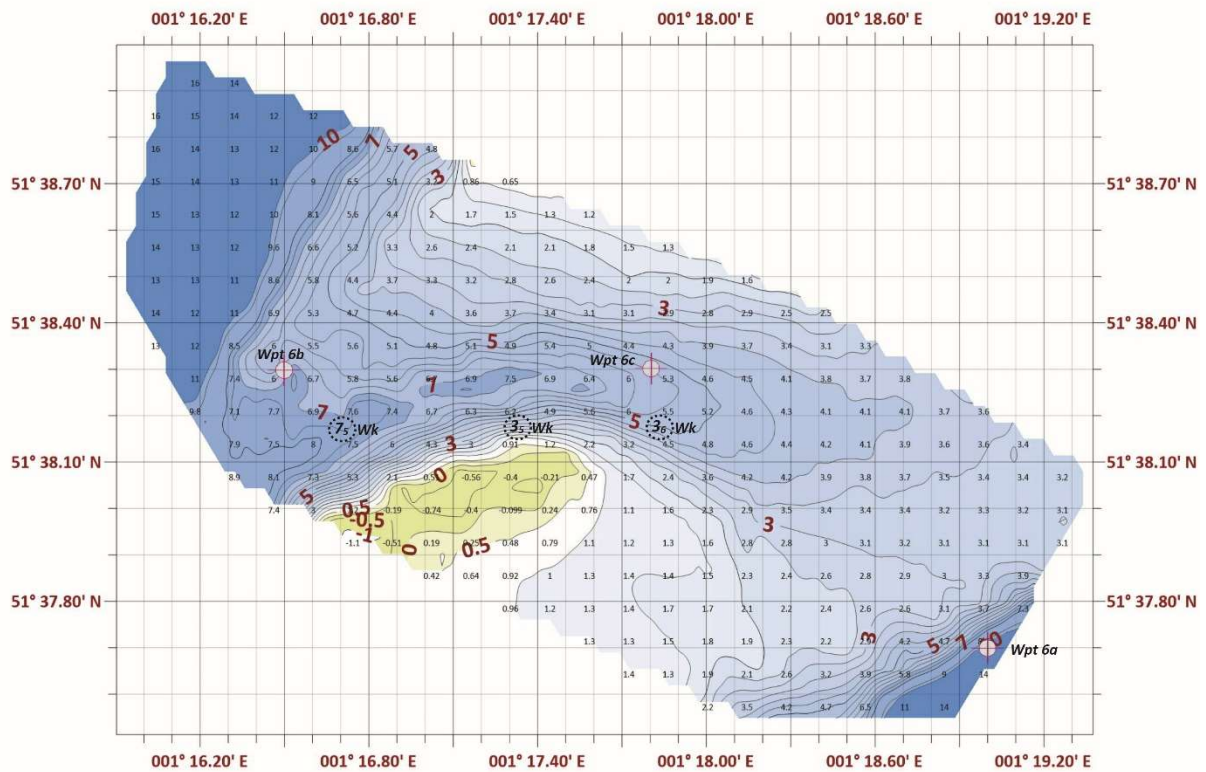
2. SW Sunk swatchway: We completed a re-survey on 18th May, 2022. The swatchway remains entirely useable (and indeed has been).

The swatchway is, though, subject to some changes. The SW Knoll is the most significant feature there and I consider the drying part of the knoll has migrated further to both the north and east. Because of the movement to the east we noticed that the tide rip that occurs in the flood tide did extend further. Because of the north and east movement I am recommending that the mid waypoint should be moved in a similar way.

Revised recommendation – Wpt 6c - 51°38'300N, 001°17'800E. Wpts 6a and 6b remain as before.

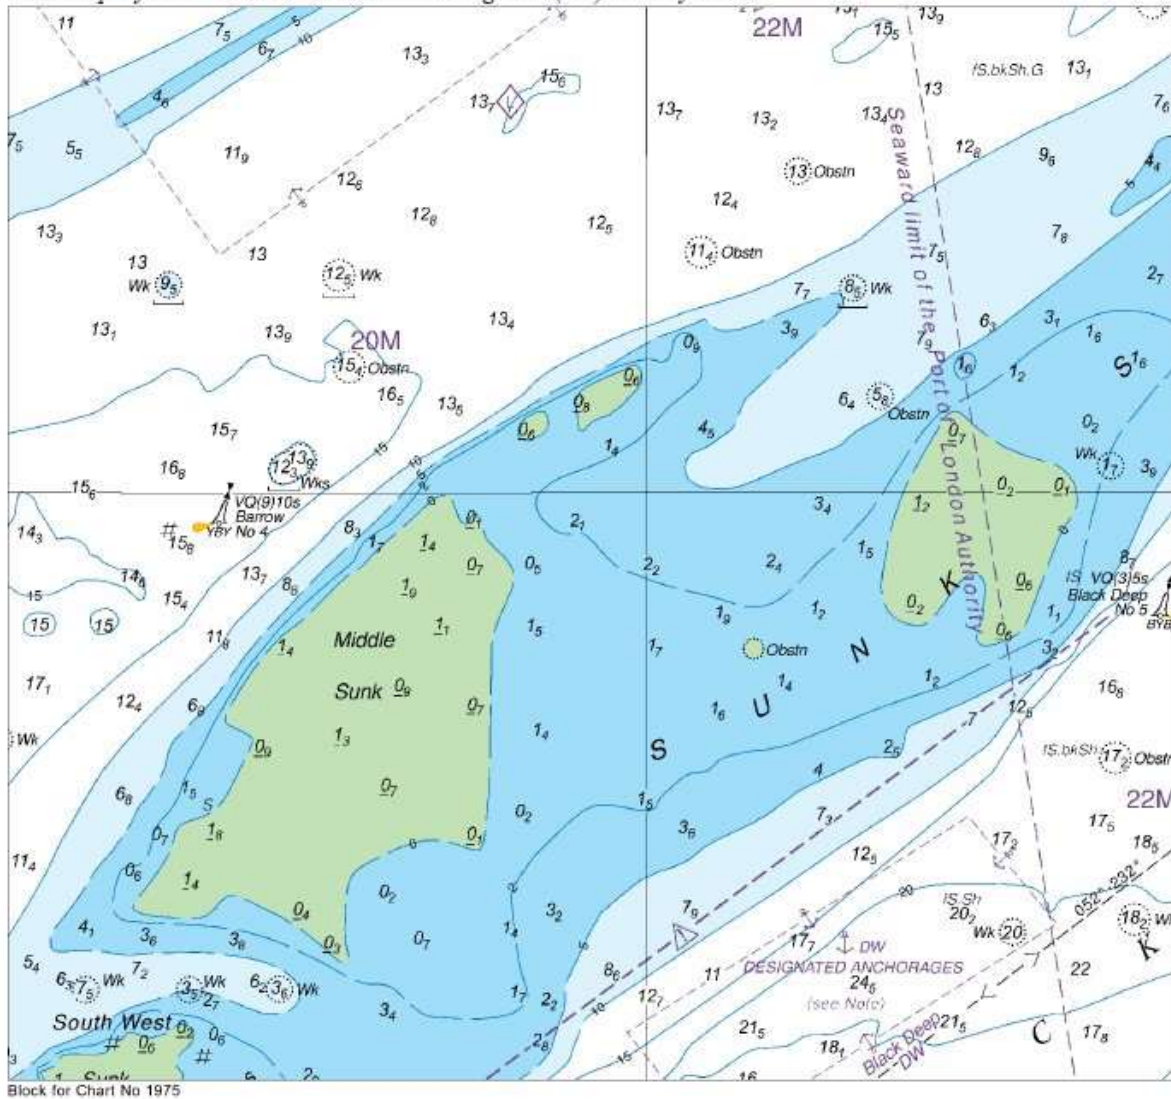
To accompany Notice to Mariners 5173/2021. Image Size (mm) 145.4 by 158.2

Note the shallow finger extending northeast from the Middle Sunk. It is possible to go round to the northeast clear of that 'finger' but it is also necessary to avoid the marked 'Obstr'. That is the remains of the old 1950's Sunk beacon. Given that while the SW Sunk swatch remains easy and safe, using the Middle Sunk to reach to and from the Essex Rivers really provides no benefit. It may be that the Middle Sunk could be a good route to and from Harwich Harbour but the data need more empirical work.

3. Middle Sunk crossing: My recommendation at present is not to use the Middle Sunk subject to a re-survey as soon as possible this year. At the end of last season we did an exploratory on the Middle Sunk. As a result of that, the UKHO issued a block using part of our data and part of a Port of London Authority survey. The result is:
